AHERA Assessment (cont)

Photographs: **PHOENIX AIRPORT TERMINAL 2**

ARIZONA HISTORY MUSEUM *aka Arizona Historical Society Building*

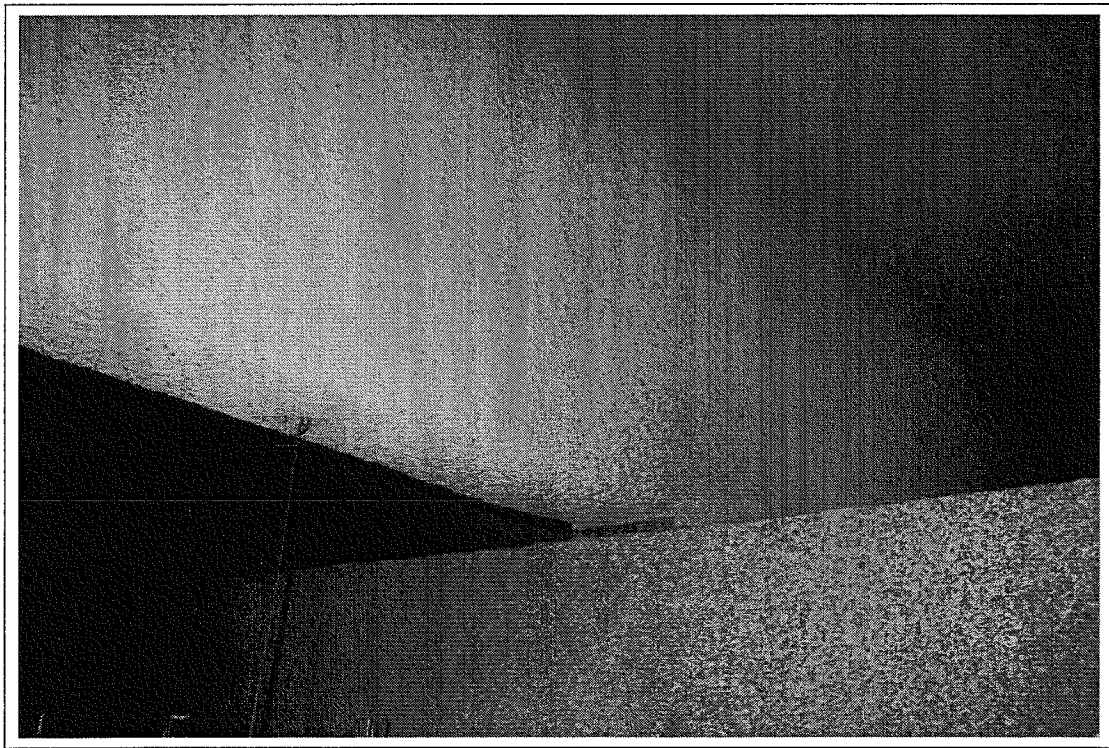
Photo 100. Main Passenger Lobby Upper Mezzanine Office Area - Fireproofing sprayed on ceiling above lay-in suspended ceiling in outside United T2T2020

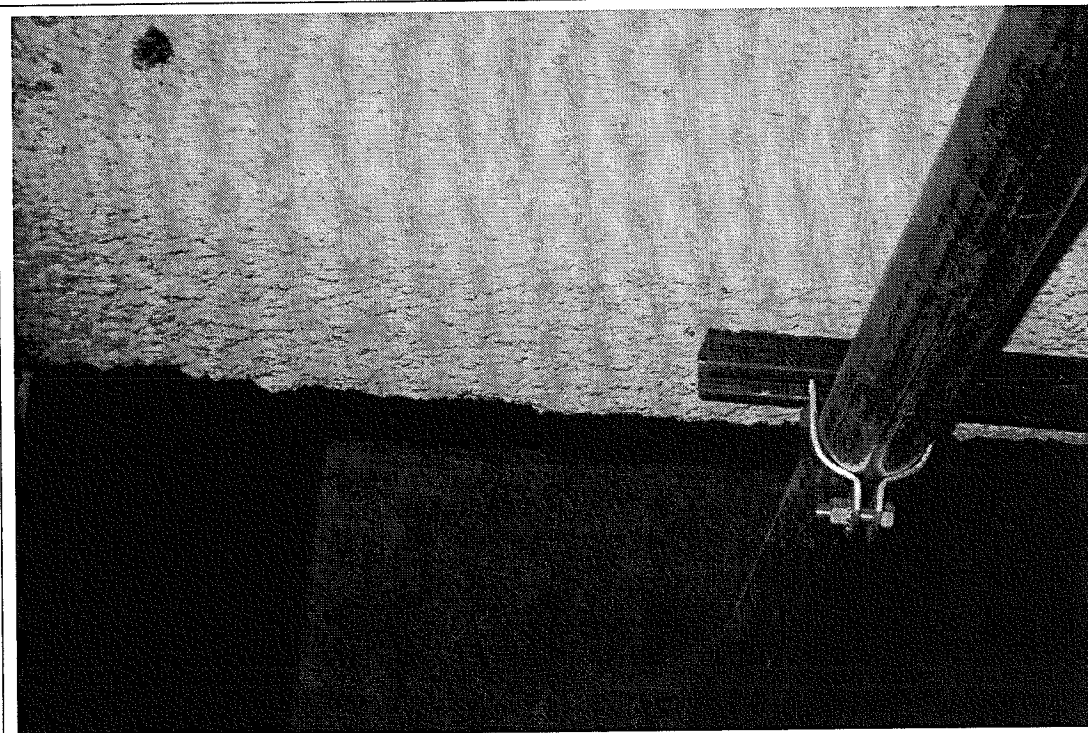
Photo 101. Main Passenger Lobby Upper Mezzanine Office Area – Conduit and anchor bar attached to fireproofed sprayed concrete deck located above suspended ceiling

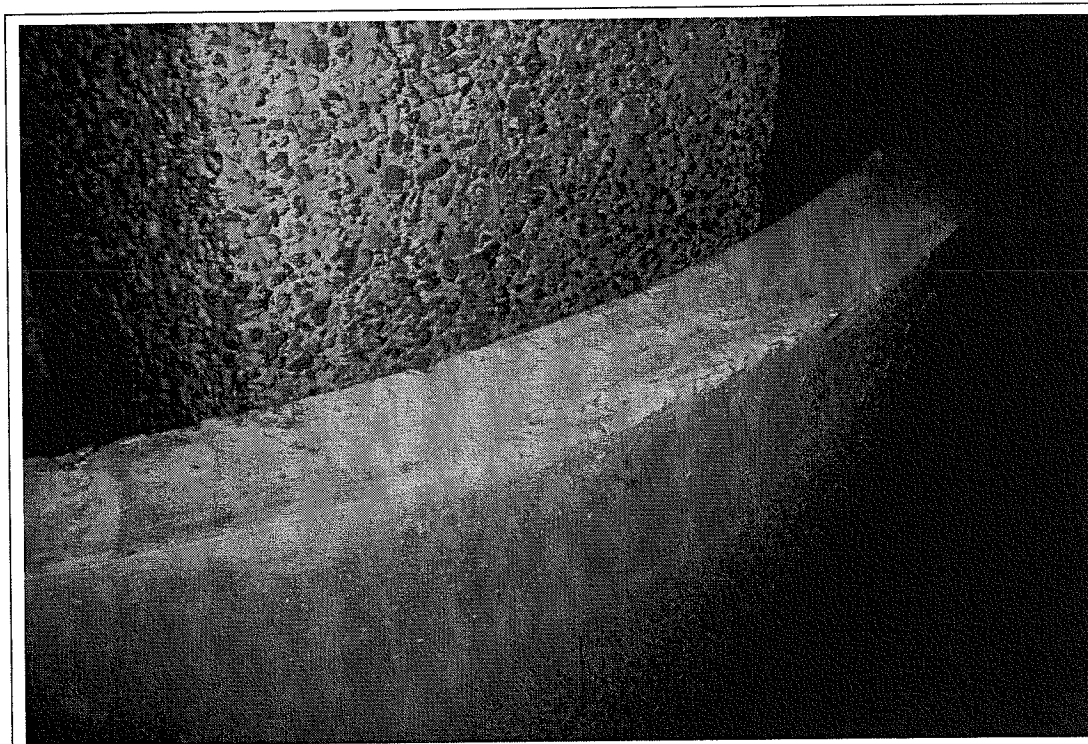
Photo 102. Main Passenger Lobby Upper Mezzanine Office Area – top of column casing situated above fireproofed sprayed deck (location of dust sample #1)

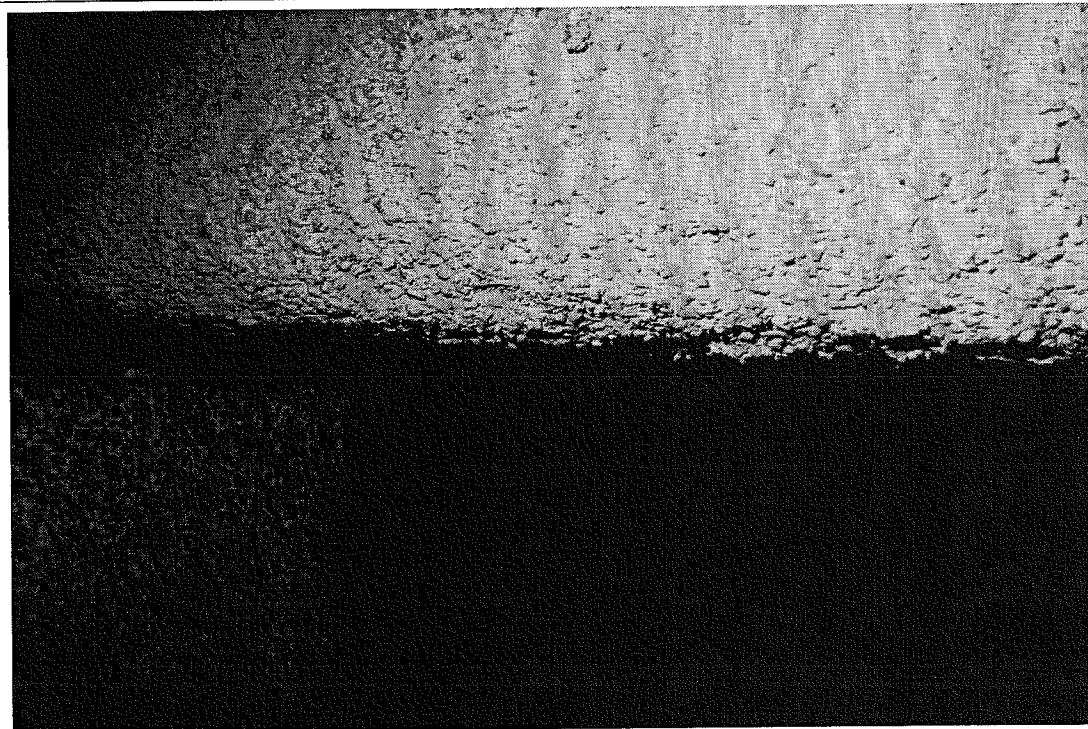
Photo 103. Main Passenger Lobby Upper Mezzanine Office Area – close-up of spray applied fireproofing on concrete deck above suspended ceiling

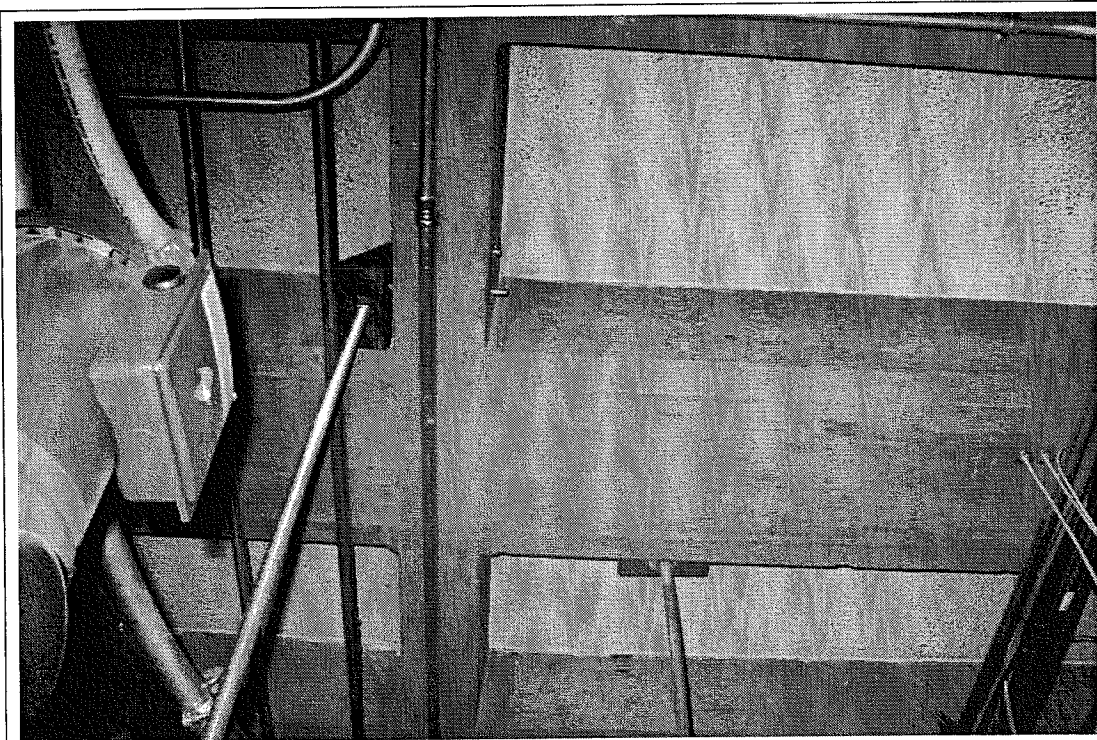
Photo 104. Fireproofing applied to concrete deck channels above West Baggage Handling area (FS2)

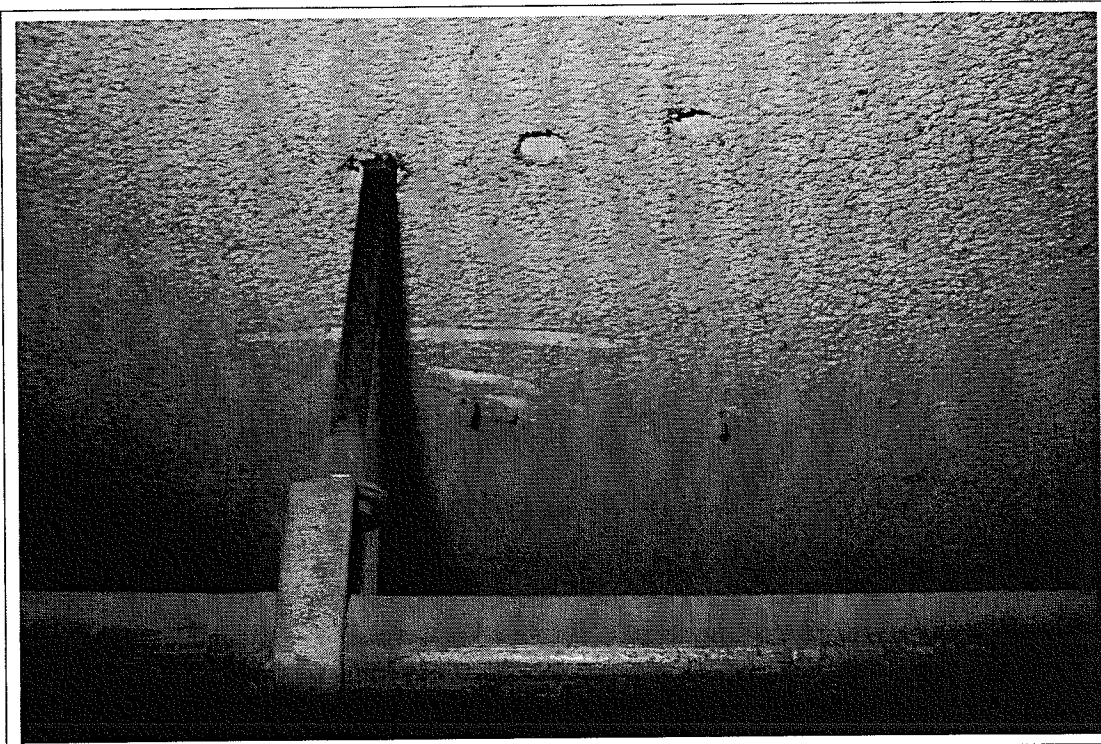
Photo 105. Impact damage and hanger rod holes in fireproofing applied to concrete deck channels above West Baggage Handling area (FS2)

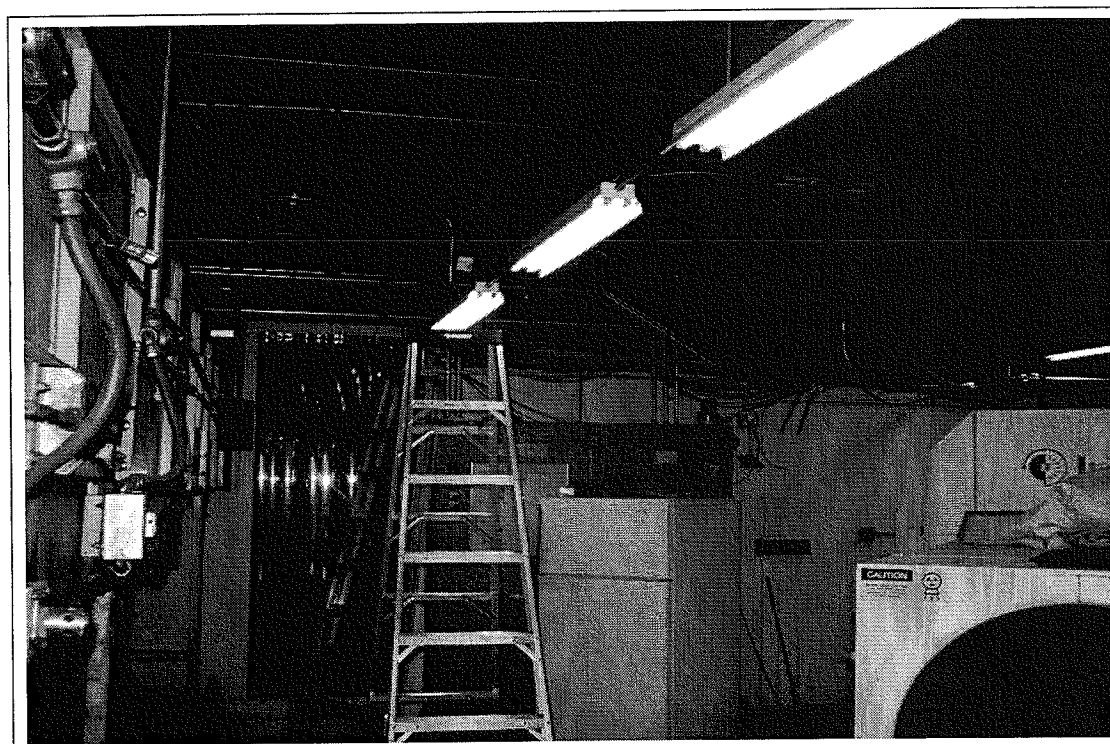
Photo 106. Location of dust sample # 2 (top of fluorescent light fixture) – West Baggage Handling area (FS2)

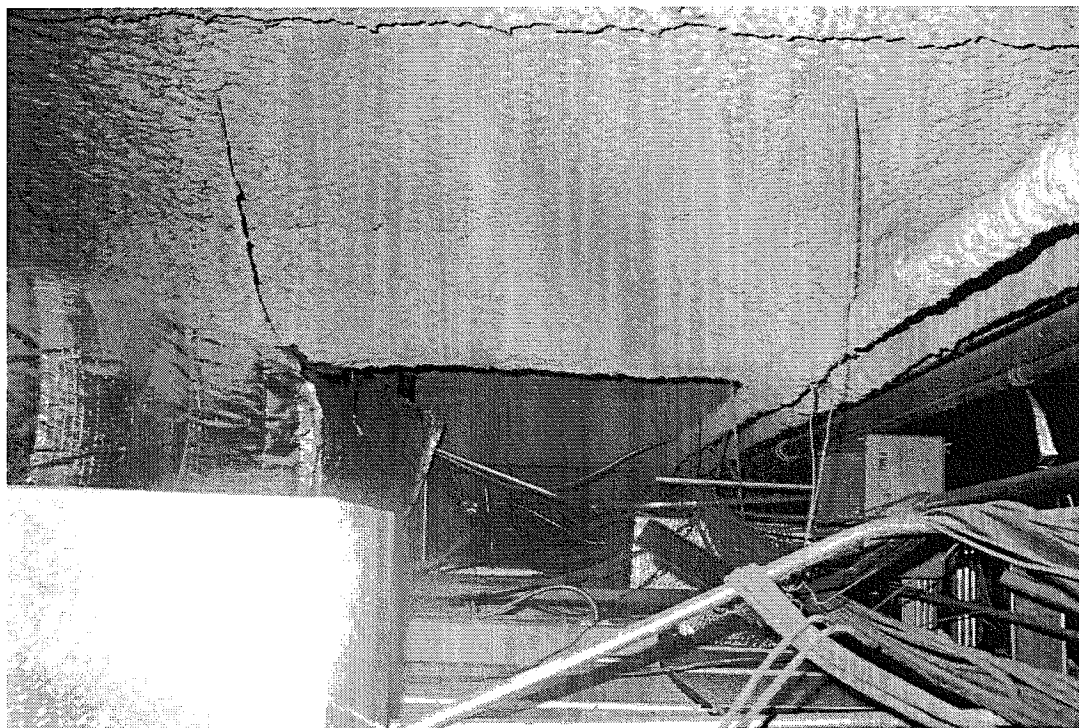
Photo 107. Fireproofing applied decking above suspended ceiling in Men's Locker Room T2C1018 located in the Lower Concourse North

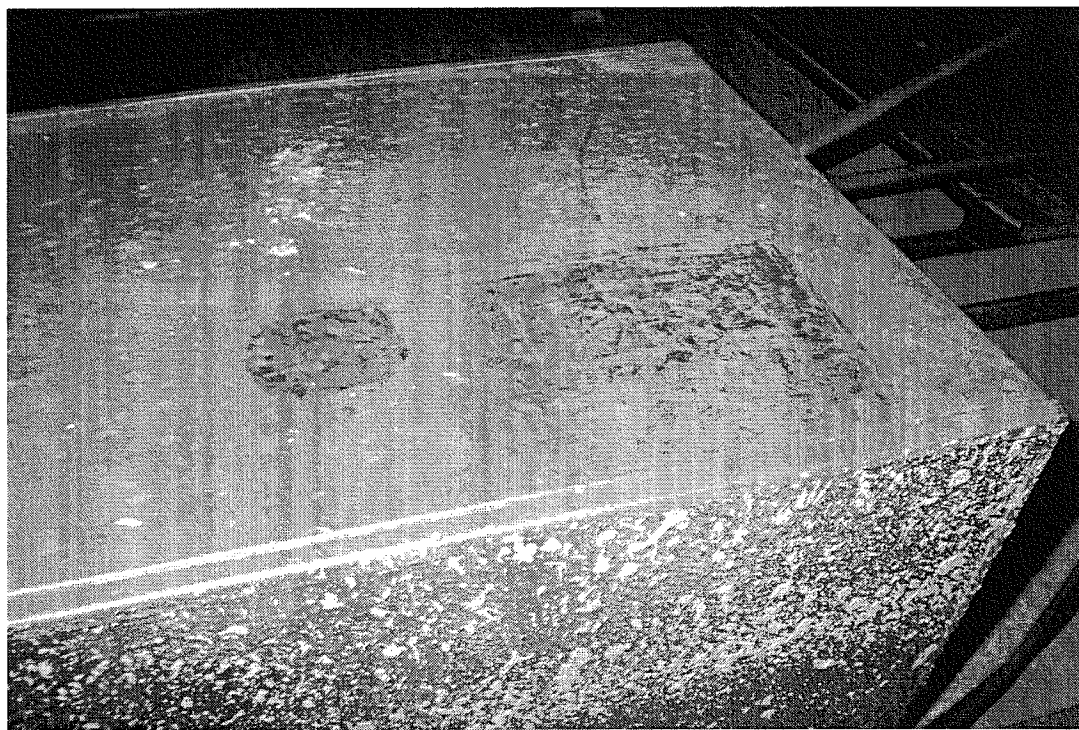
Photo 108. Location of dust sample # 3 and surface contact sample A (top of metal HVAC duct) above suspended ceiling - Men's Locker Rm., Lower Concourse North
